Active Screening Assessment Reports (ASARs) for GatherCo Sale Facilities

Phase II

ACTIVE SCREENING ASSESSMENT REPORTS (ASARs) FOR GATHERCO-PHASE II SALE AREA

Submitted By COLUMBIA GAS TRANSMISSION CORPORATION Charleston, West Virginia

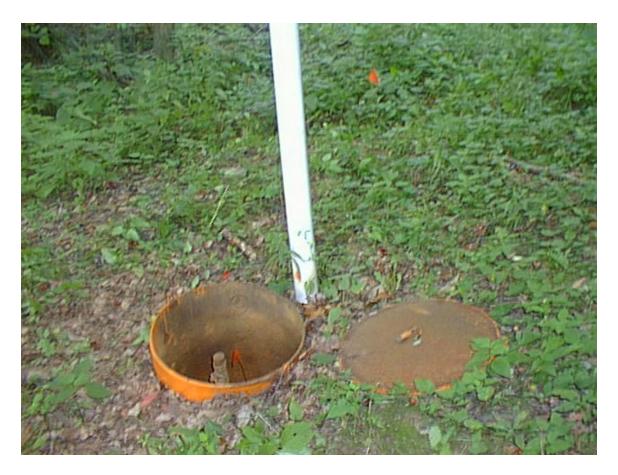
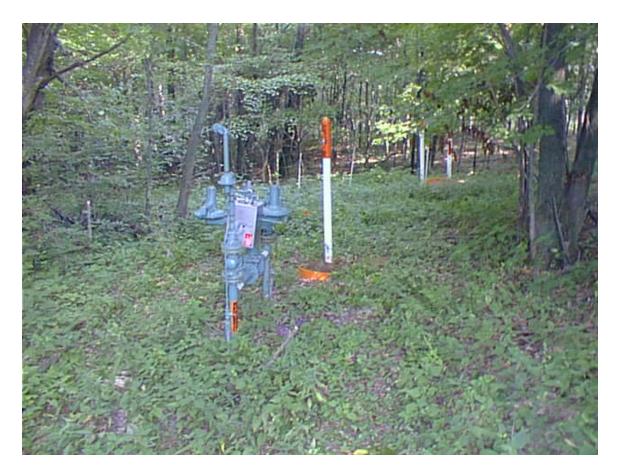
Facility ID: L05001 Photo Date:07/29/98 10:13 SIPHON ON LINE J-46 AT STATION 1062+52

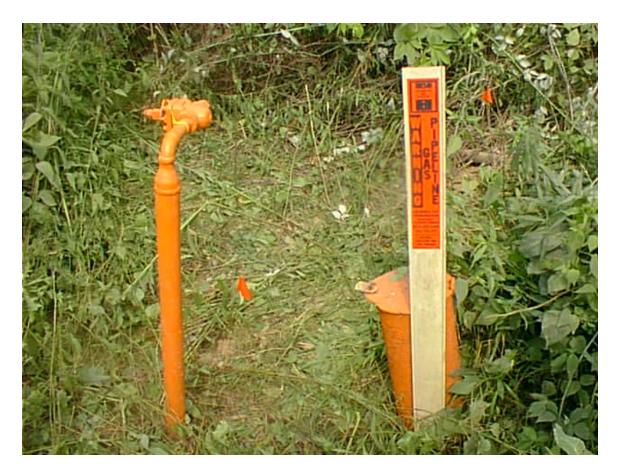
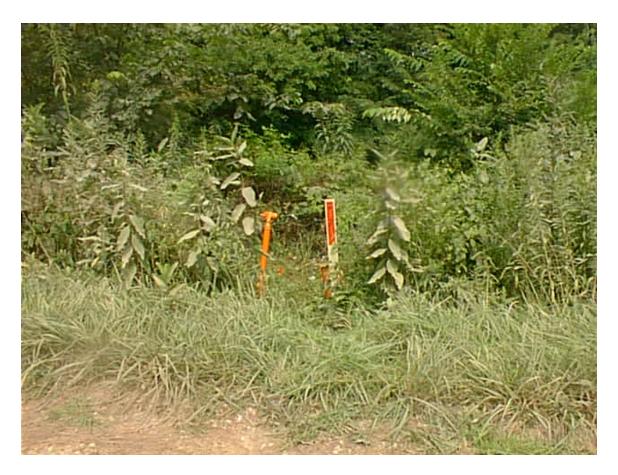
Facility ID: L05002 Photo Date:07/29/98 11:57 HORIZONTAL DRIP ON LINE J

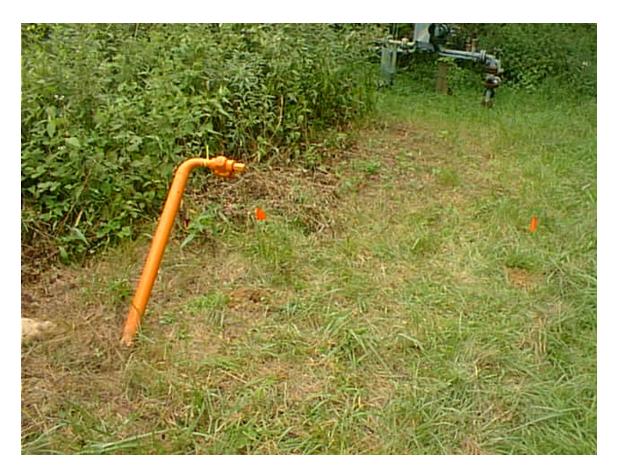
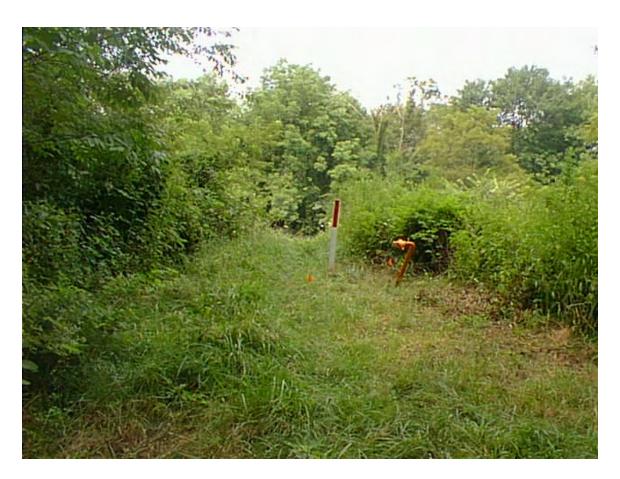
Facility ID: L05003 Photo Date:07/29/98 11:58 HORIZONTAL DRIP ON LINE J

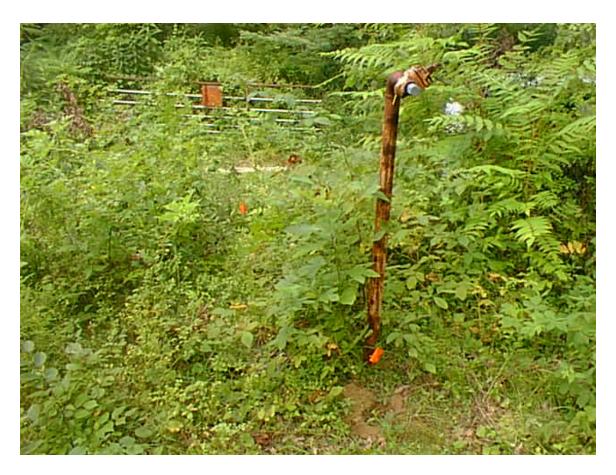
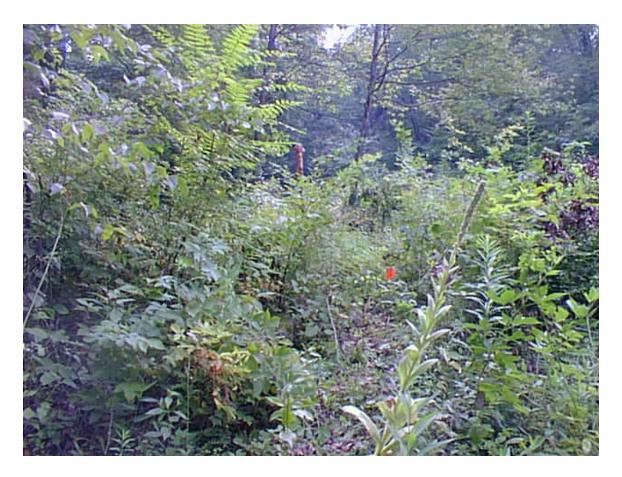
Facility ID: L05004 Photo Date:08/04/98 10:18 HORIZONTAL DRIP ON LINE J AT STATION 1114+80

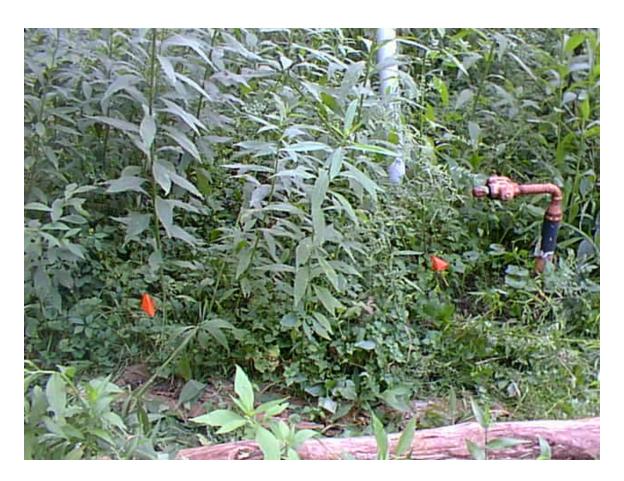
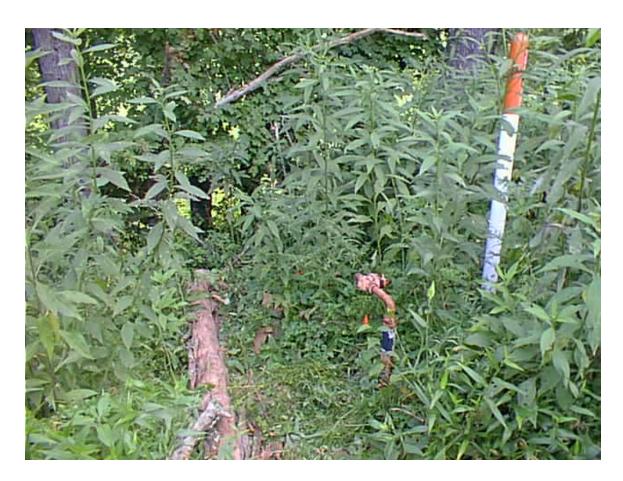
Facility ID: L05005 Photo Date:08/04/98 12:04 HORIZONTAL DRIP ON LINE J AT STATION 1149+93

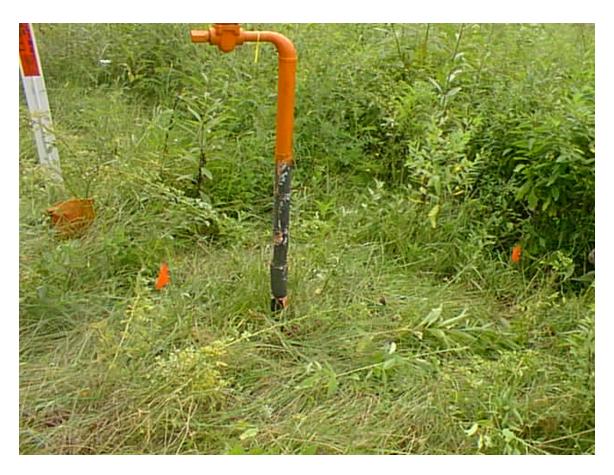
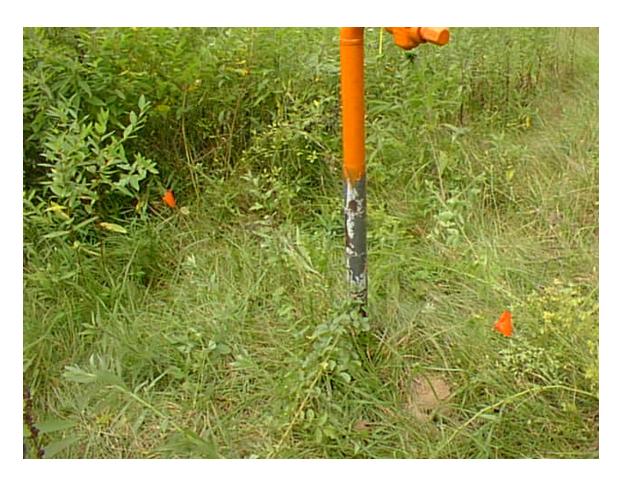
Facility ID: L05006 Photo Date:08/04/98 14:27 HORIZONTAL DRIP AT METER 720307 ON LINE J-54

Facility ID: L05006 Photo Date:08/04/98 14:28 HORIZONTAL DRIP AT METER 720307 ON LINE J-54

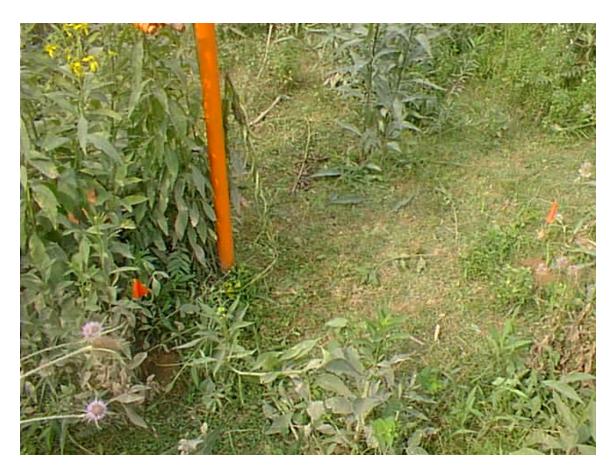
Facility ID: L05007 Photo Date:08/05/98 10:31 HORIZONTAL DRIP ON LINE J-54 AT STATION 194+64

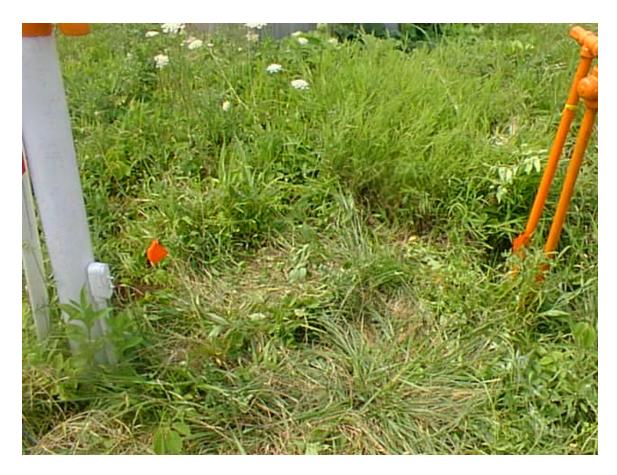
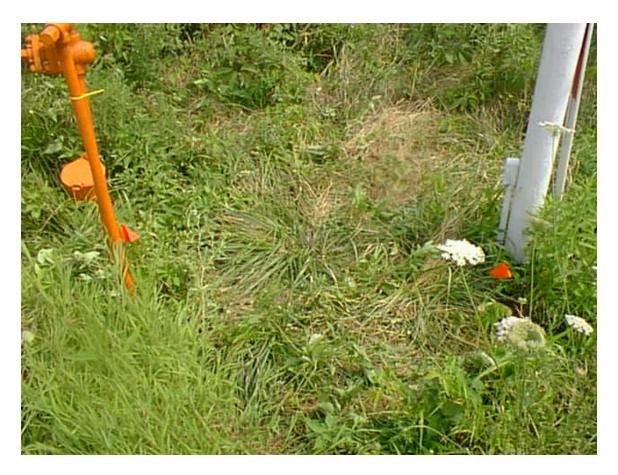
Facility ID: L05008 Photo Date:08/05/98 12:08 HORIZONTAL DRIP ON LINE J-54 AT STATION 297+15

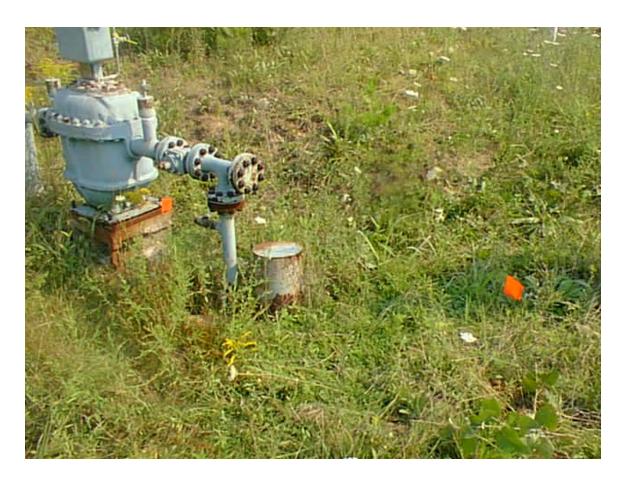
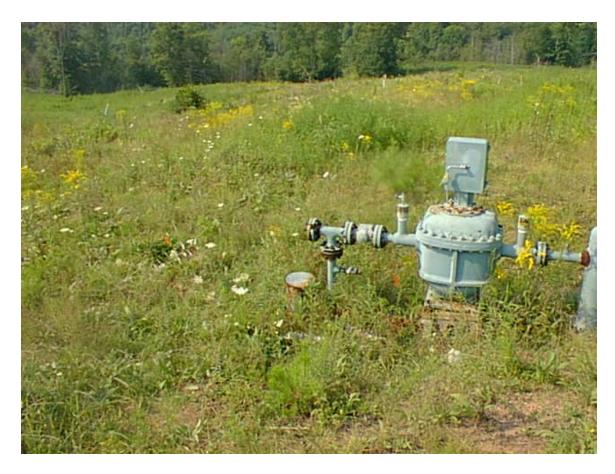
Facility ID: L05009 Photo Date:08/06/98 10:26 DISPLACEMENT METER 731230 ON LINE Q-930

Facility ID: L05009 Photo Date:08/06/98 10:27 DISPLACEMENT METER 731230 ON LINE Q-930

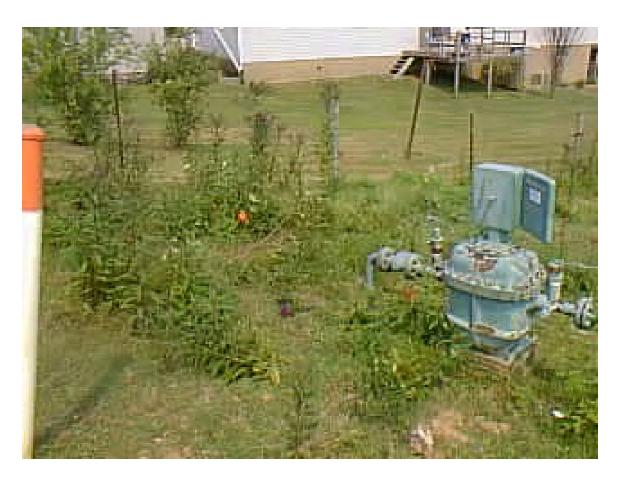
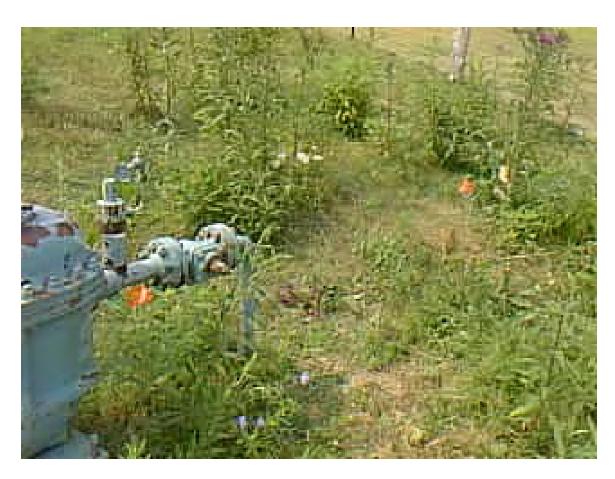
Facility ID: L05010 Photo Date:08/06/98 12:03 DISPLACEMENT METER 732042 ON LINE Q-926

Facility ID: L05010 Photo Date:08/06/98 12:04 DISPLACEMENT METER 732042 ON LINE Q-926

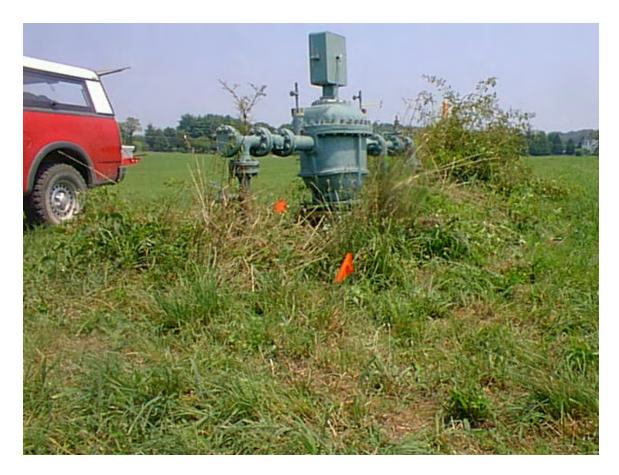
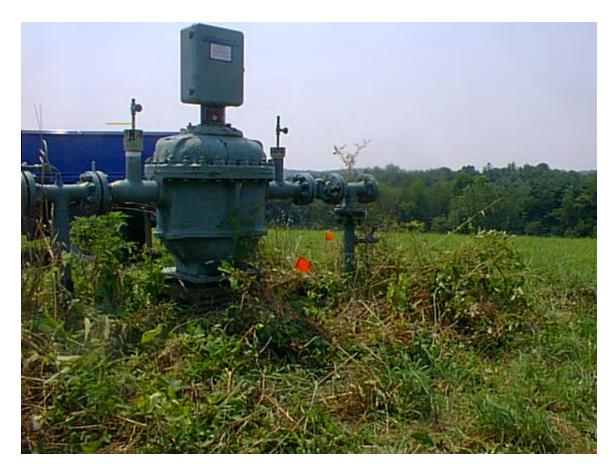
Facility ID: L05011 Photo Date:08/06/98 13:58 DISPLACEMENT METER 722705 ON LINE Q-926

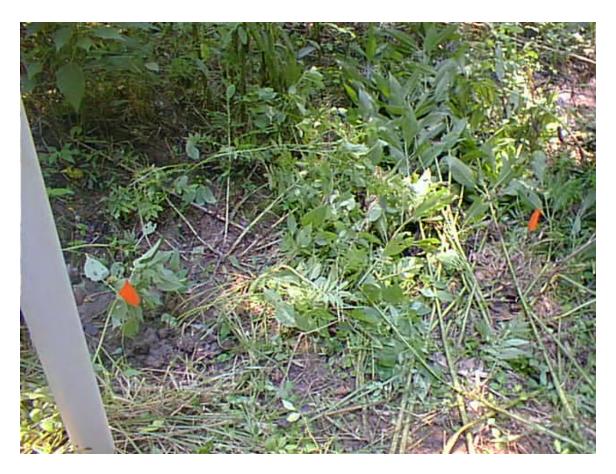
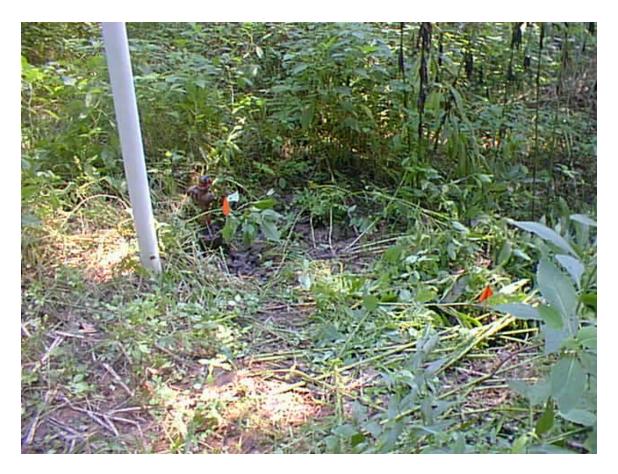
Facility ID: L05012 Photo Date:08/06/98 15:20 HORIZONTAL DRIP ON LINE Q-926 AT STATION 617+39

Facility ID: L05012 Photo Date:08/06/98 15:21 HORIZONTAL DRIP ON LINE Q-926 AT STATION 617+39

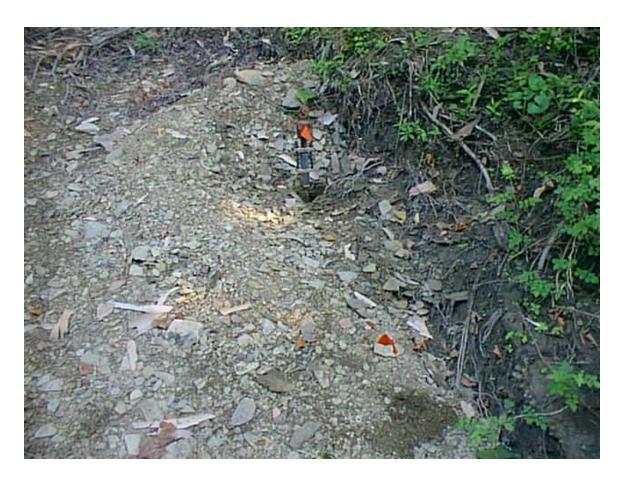
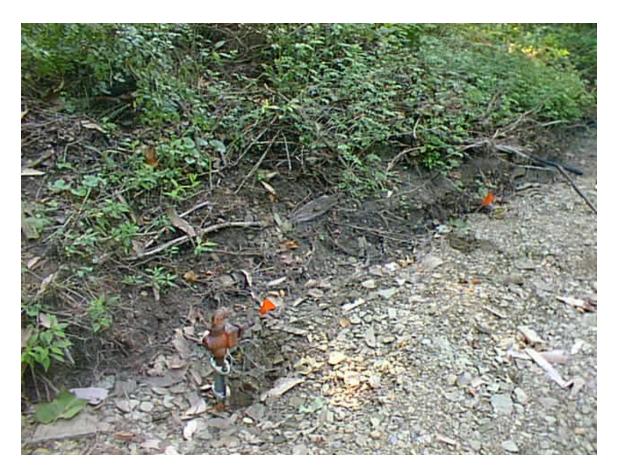
Facility ID: L05013 Photo Date:08/07/98 10:03 SIPHON ON LINE H-118 AT STATION 243+28
